Manhole Inspection Summary

Manhole # S45AA_052MH

Insp Date: **3/17/10 11:56 AM**

Location Address: **720 Rutland Ave.**

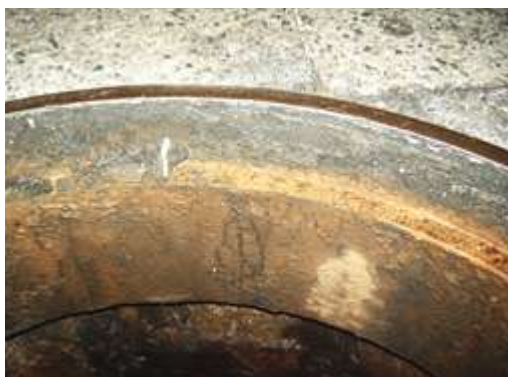
Defect 1

Frame Offset: **0** (in.) Condition: ☐ Sound ☐ Cracked ☒ **Leaks**

frame leaks

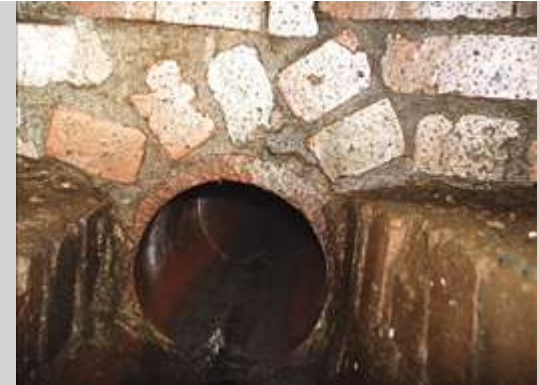
12 O'Clock Outflow

8 in. Circular Gravity Sewer
Pipe Out @ 12 O'Clock

Pipe Height: **12** (in.) Rod and Bar (Angled)
Pipe Material: **Clay** ☐ Pipe Lined
Invert Depth: **15.42** (ft.) Flow Characteristics: **Slow**
Deposits: ☒ None ☐ Mud ☐ Sludge ☐ Debris ☐ Grease
Silt Depth: (in.) Deposits Extent:
Infiltration: **None** Pipe Seal Cond: **Sound**

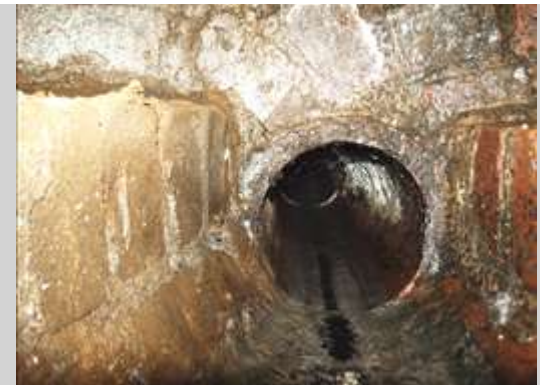
3 O'Clock Inflow

6 in. Circular Gravity Sewer
Pipe In @ 3 O'Clock

Pipe Height: **9.6** (in.) Rod and Bar (Angled)
Pipe Material: **Clay** ☐ Pipe Lined
Invert Depth: **15.08** (ft.) Flow Characteristics: **Slow**
Deposits: ☒ None ☐ Mud ☐ Sludge ☐ Debris ☐ Grease
Silt Depth: (in.) Deposits Extent:
Infiltration: **None** Pipe Seal Cond: **Sound**
